TITLE VI ACCOMPLISHMENTS & GOALS REPORT - WSDOT

ADA Transition Plan

Prepared by Transpo Group
December 2023

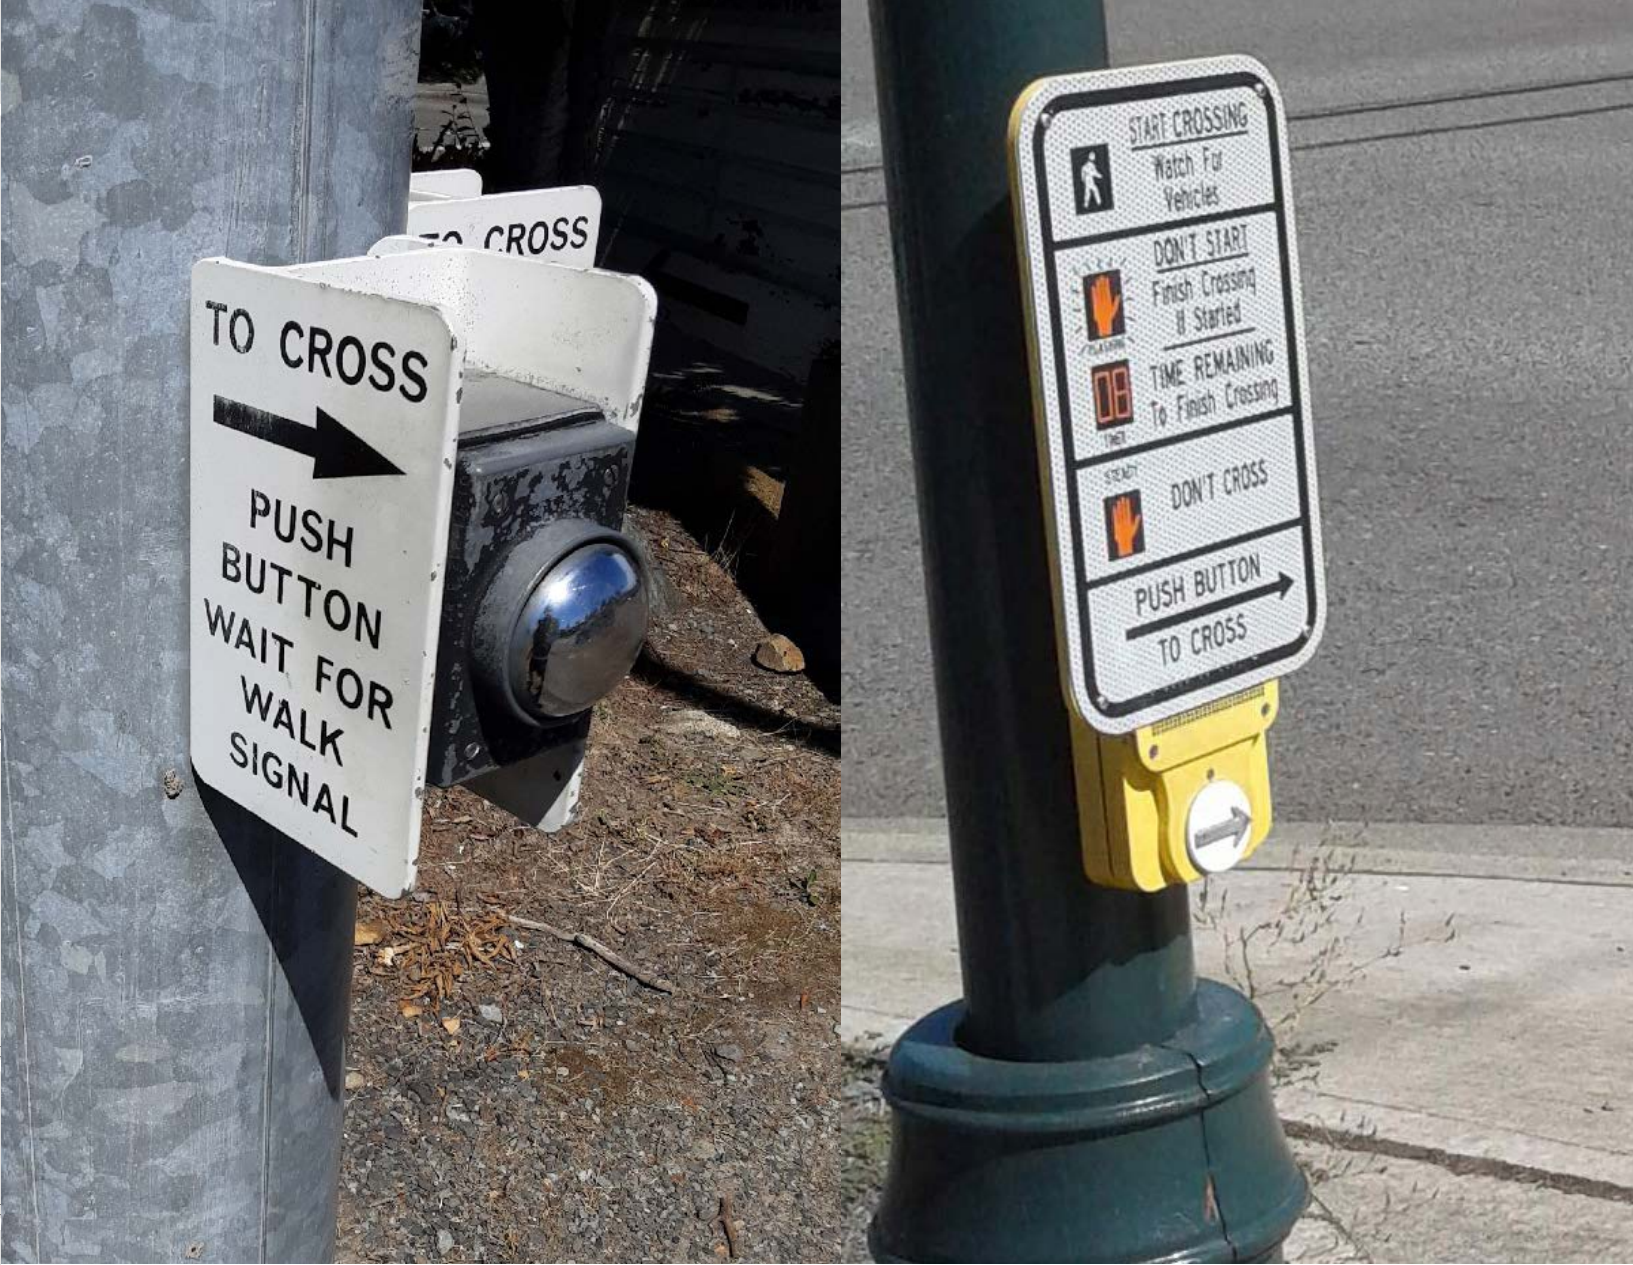
Figure 2-17 “H-style” (left) and APS-style (right) pedestrian pushbutton

66 of the 74 inventoried pedestrian pushbuttons were non-APS style. The non-compliant pedestrian pushbuttons include non-APS style buttons to be replaced and APS-style buttons to be reprogrammed or relocated.

accessibility but must be fully replaced with an accessible pedestrian signal (APS)-style pushbutton to achieve full ADA compliance (see Figure 2-17).
